As part of Network Rail's upgrade, the platform on Blackfriars Bridge in London will have to be extended to allow much longer trains to travel along the Thameslink line. They needed to check that the composition of the 1870 bridge piers and underlying clay could take the extra load.

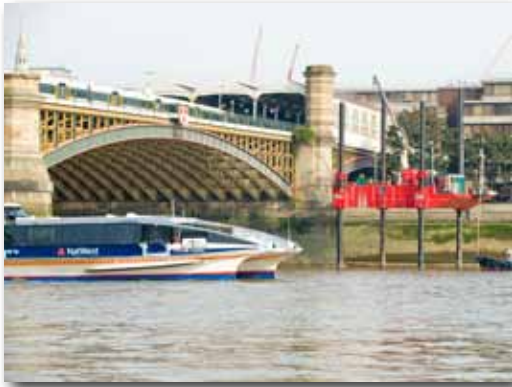
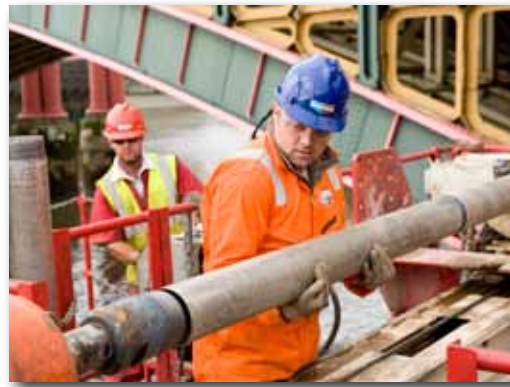
The work presented many challenges, not least the fact that the station and bridge had to remain open, and manoeuvring Skate 2E and associated plant and machinery required very precise planning.

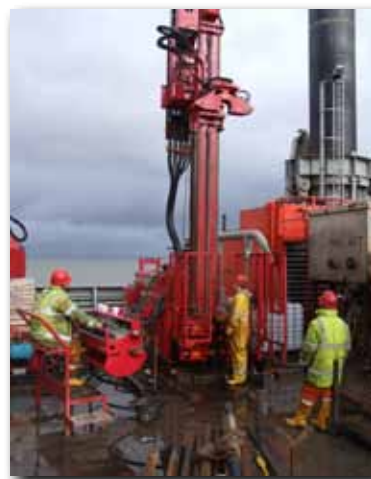
In addition there was a requirement for high-speed rotary coring through the piers from the horizontal to the sub-vertical which was conducted with Geobor-S triple tube wireline coring equipment, obtaining a core with a nominal 102mm diameter. All cores were recovered in clear plastic liners, labelled and boxed onboard the jack-up.

On completion of drilling and testing the holes were grouted to surface with gel modified grout. Throughout the project

drilling rates were approx. one metre an hour with 100% core recovery. A number of the holes required CCTV surveys to check for any voids. The piers were found to be in excellent condition with strong intact brickwork and concrete throughout.
